THE SHOCK TUNNEL:
HISTORY AND RESULTS

Final Report

7618-1 Final Report

by
C. Wilton, K. Kaplan, and B.L. Gabrielsen
Scientific Service, Inc.
1536 Maple Street
Redwood City, CA 94063

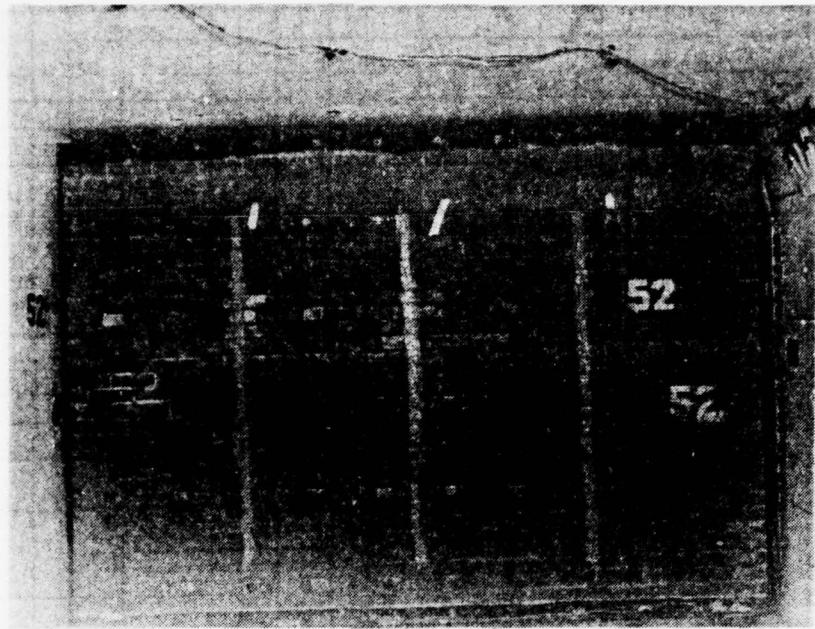
Fig. 2-11. Pre and Posttest Photograph of 12 in. Non-reinforced Brick Wall No. 52. Peak Loading Pressure \approx 4.2 psi.

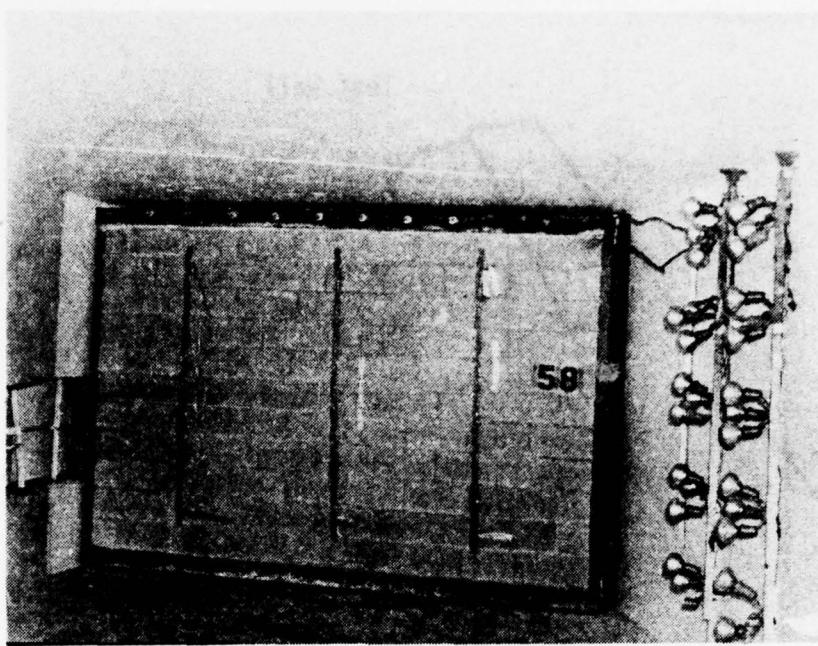
Fig. 2-14. Pre and Posttest Photographs of Wall No. 58. Non-reinforced Concrete Block Interior Wall. Peak Loading Pressure \approx 1.5 psi.

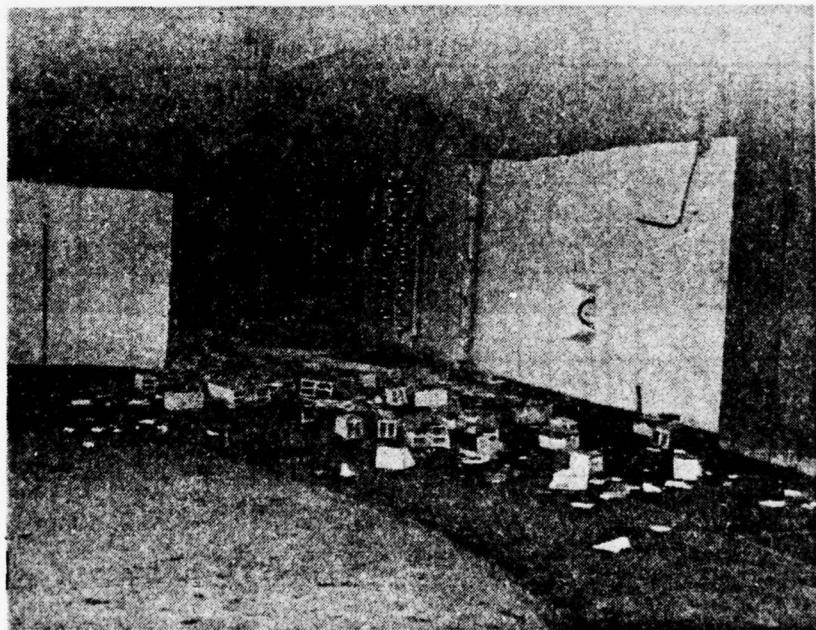
Fig. 2-16. Posttest Photographs, Wall No. 62, Non-reinforced Hollow Clay Tile Interior Wall. Peak Loading Pressure \approx 1.5 psi.

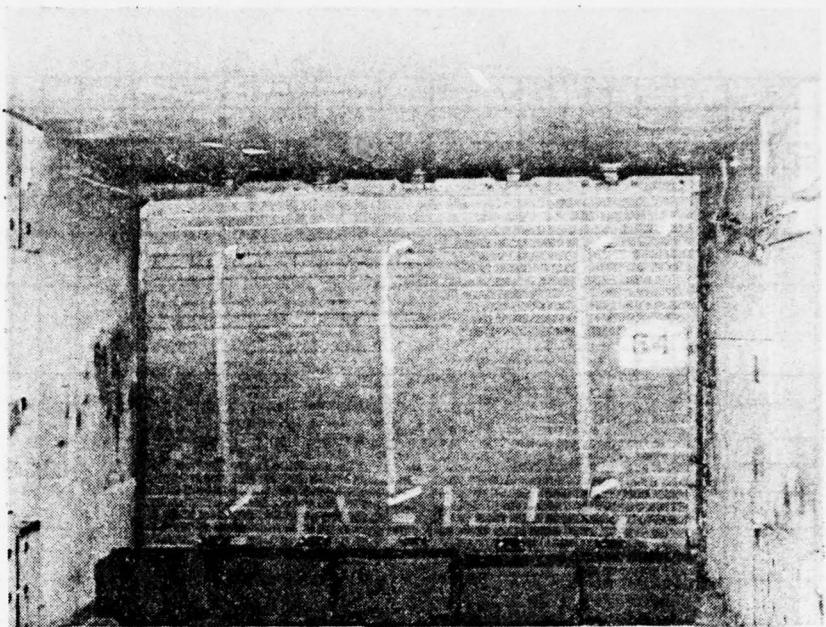
Fig. 2-18. Pre and Posttest Photographs of Wall No. 64, Preload was 2W; Loading Pressure was 1.6 psi.

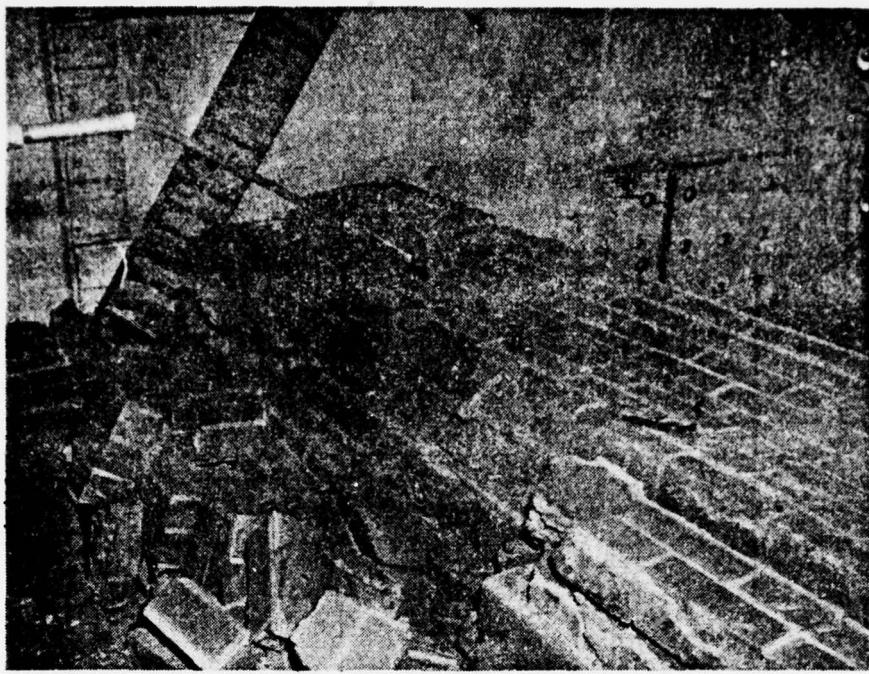
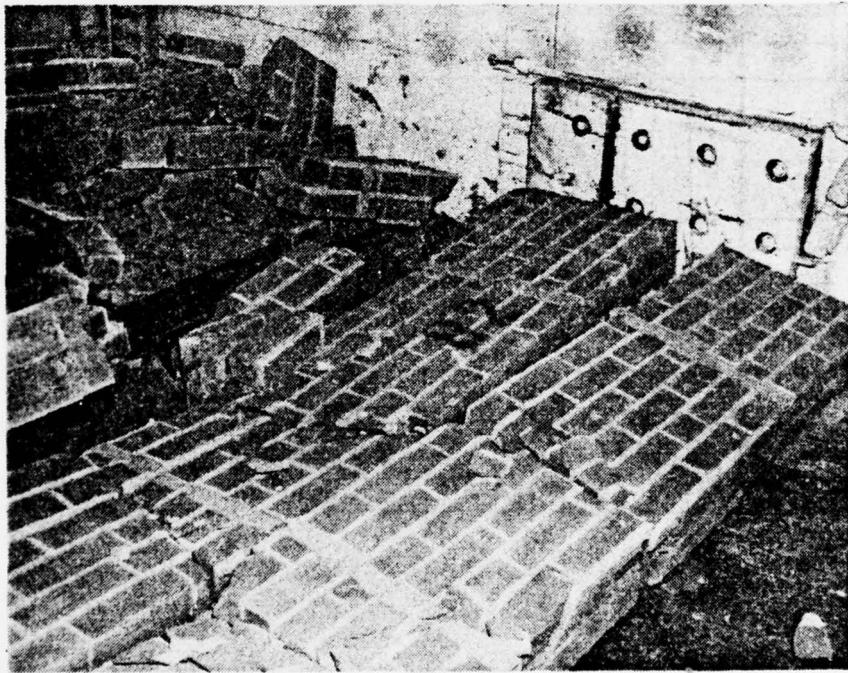
Wall No. 65.

Wall No. 82.

Fig. 2-19. Posttest Photographs of Walls No. 65 and 82. Preload on Wall No. 65 was 2W; Loading Pressure was 1.6 psi. Preload on Wall No. 82 was 3.5W; Loading Pressure was 4.0 psi.

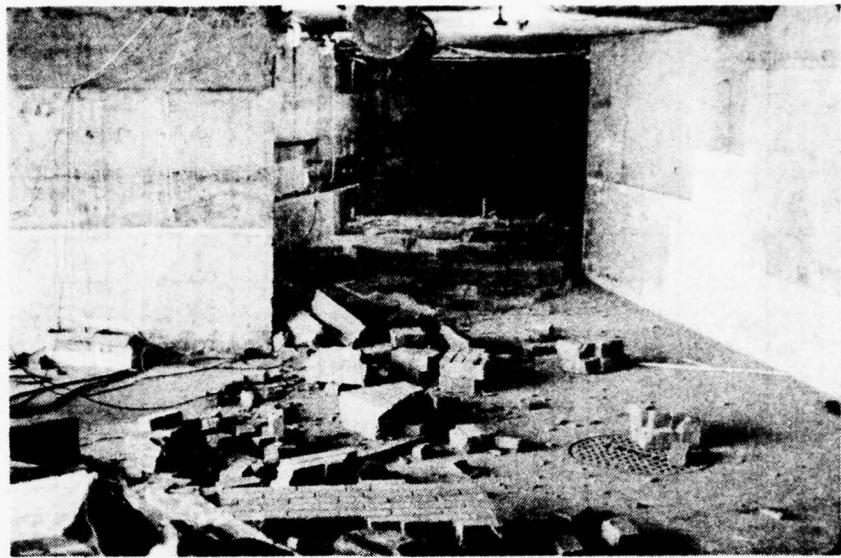
B. Test Wall No. 7.

Fig. 2-22. Photograph of Debris, and a Debris Distribution Chart from Tests on 8-in. Thick Brick Walls, Mounted as Simple Beams, and Subject to Blast Loading Pressures of 3.6 psi. The Numbers on the Charts Represent the Weight of the Largest Piece of Debris Found in the Distance Range in lb.

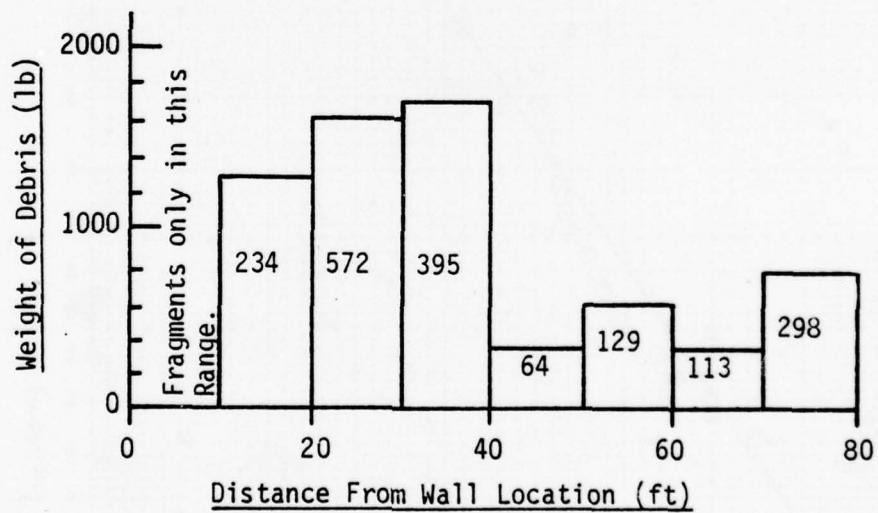
A. Test Wall No. 4.

Fig. 2-23. Photograph of Debris, and a Debris Distribution Chart from Tests on 8-in. Thick Brick Walls Mounted as Simple Beams and Subject to Blast Loading Pressures of 10 psi. The Numbers in each Bar of the Chart Represent the Weight of the Largest Piece of Debris Found in the Distance Range in lb.

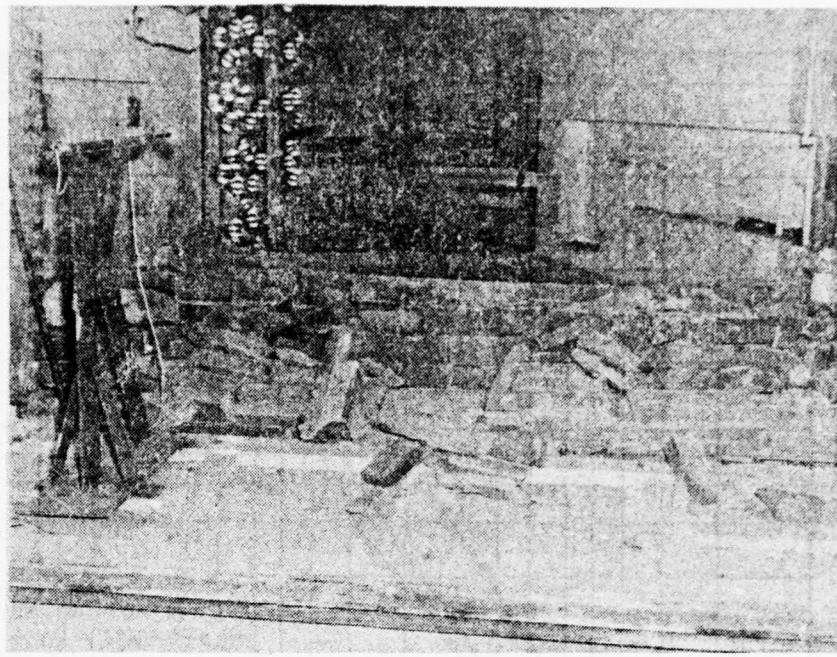
At the end of the series of tests run on each wall, in all but one case the wall had collapsed, with the largest amount of debris landing within 10 ft of the initial wall position, though with smaller pieces of debris being thrown as far as 30 ft. Photographs of debris from two of the test series are shown in Fig. 3-8. With all eight walls, cracking first took place at the corners of the windows, and progressed horizontally across the wall face.

Both preloaded brick walls were subjected to two tests, the first using a nominal peak reflected pressure of 1.6 psi; the second using 4.3 psi. In both cases, the first tests caused no apparent damage. With Wall No. 69, the second test caused cracking at the top of the window opening (the earliest crack occurring 7 msec after the initial loading), but the wall did not fail. With Wall No. 70, the second test caused wall failure, as shown in Fig. 3-8A. A plot of displacement at the horizontal centerlines of Walls No. 56, 57, and 70 (the three walls that failed) is shown in Fig. 3-9.

A. Brick Wall No. 70. Loading Pressure \approx 4.3 psi.

B. Concrete Block Wall. Second Test at Loading Pressure \approx 1.6 psi.

Fig. 3-8. Posttest Photographs of Brick and Concrete Block Walls with Windows.

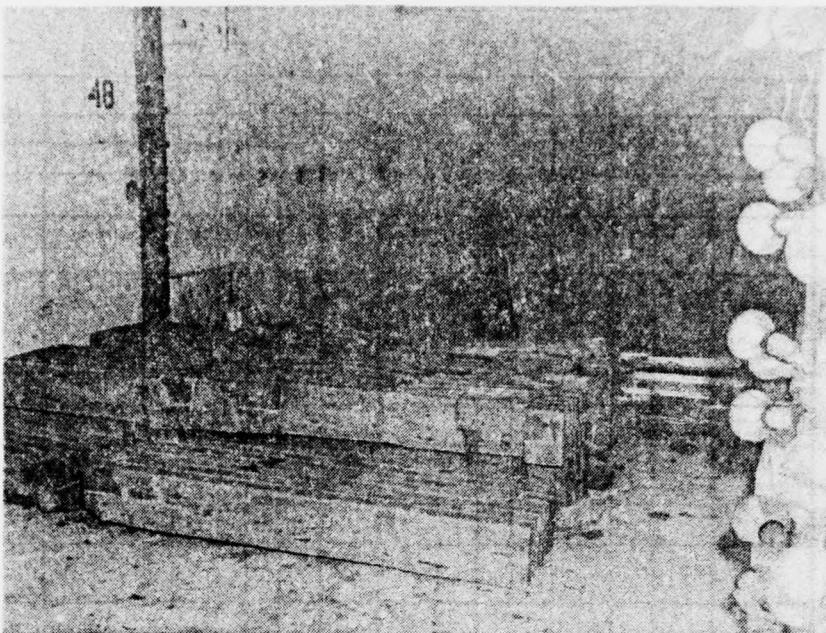
A. Wall No. 48.

B. Wall No. 45.

Fig. 4-7. Posttest Photographs of Walls No. 45 and 48, 8-in. Non-reinforced Brick Walls with a Doorway. Loading Pressure for Both Walls \approx 4 psi.

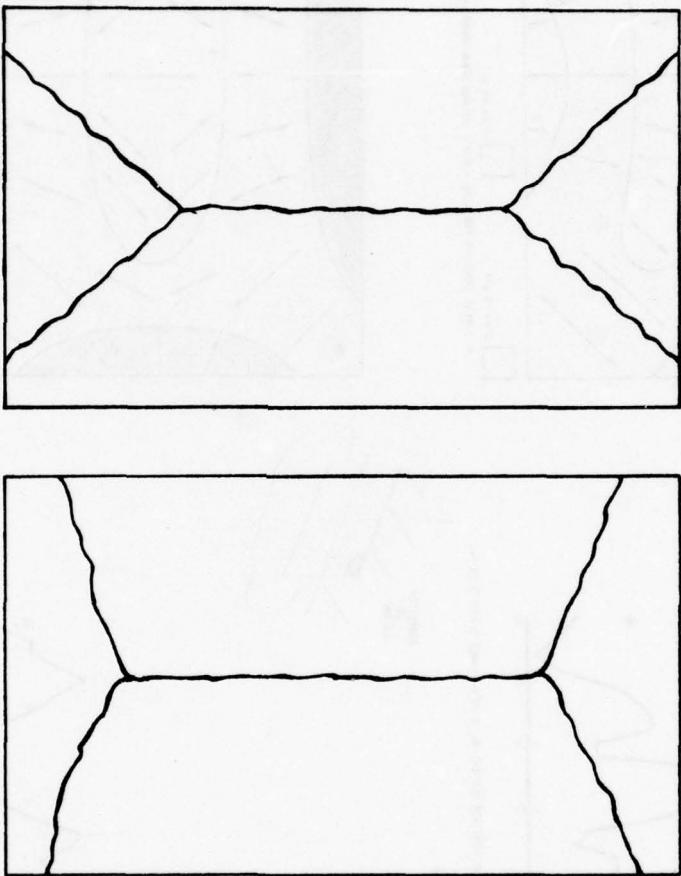
Four of the walls (24, 25, 27, and 29) which were exposed to measured peak loading pressures ranging from 3.2 psi to 4.0 psi, cracked as a result of the test, but did not collapse, though a 500-lb section of Wall No. 27 did fall out. The fifth wall (No. 28), subjected to a 4.0 psi loading did collapse. The crack patterns taken from high speed motion picture records of the downstream faces of these walls are shown in Fig. 5-4, and photographs of the cracks on the downstream face of Wall No. 24 are shown in Fig. 5-5.

The similarity between these crack patterns and those predicted by SAMIS

in Fig. 5-3 are apparent, clearly indicating that the walls responded as plates with pinned supports on all sides up to the time they cracked. If they had continued to do so after cracking, they would have failed under the blast loading. The mortar used in their construction, however, tended to bond the wall panels to the steel frame members in which they were constructed, and which were themselves pinned to the support girders (see Appendix A). With a wall deflection after fracture of more than a few tenths of an inch, these support members became a perimeter restraining ring, the bond of the wall to the frame at wall corners having the effect of making the perimeter continuous in nature instead of being free at each corner. This continuity provided thrust resistance and permitted a wall to go into an arching mode of response and be more resistant to ultimate failure than it would have been if it continued to have simple pinned supports. The phenomenon is illustrated in Fig. 5-6.

Fig. 5-4. Crack Patterns from Plate-Mounted Solid Walls, Peak Reflected Pressures = 3.2 to 3.8 psi,
Walls No. 24, 25, 27, 29.

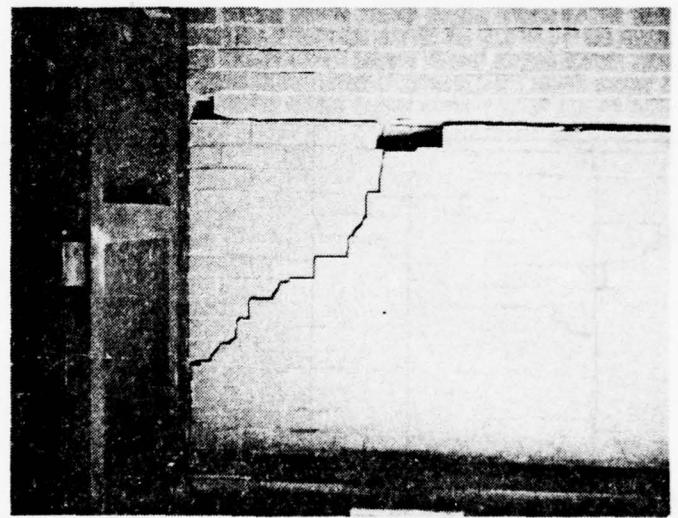
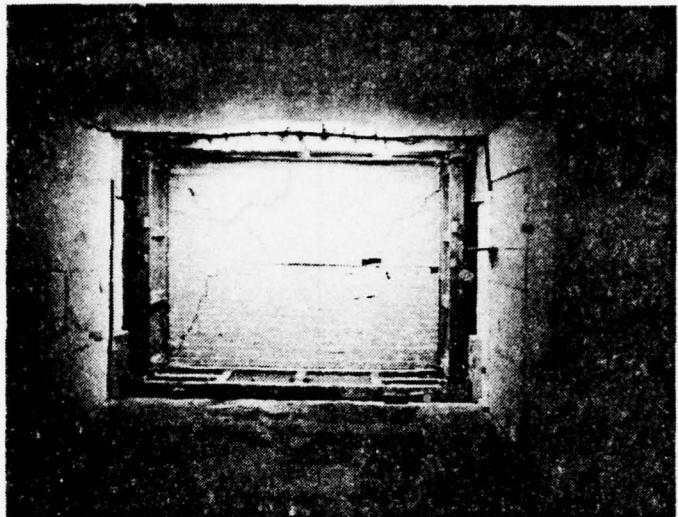
Fig. 5-5. Cracking on the Downstream Face of Wall No. 24.

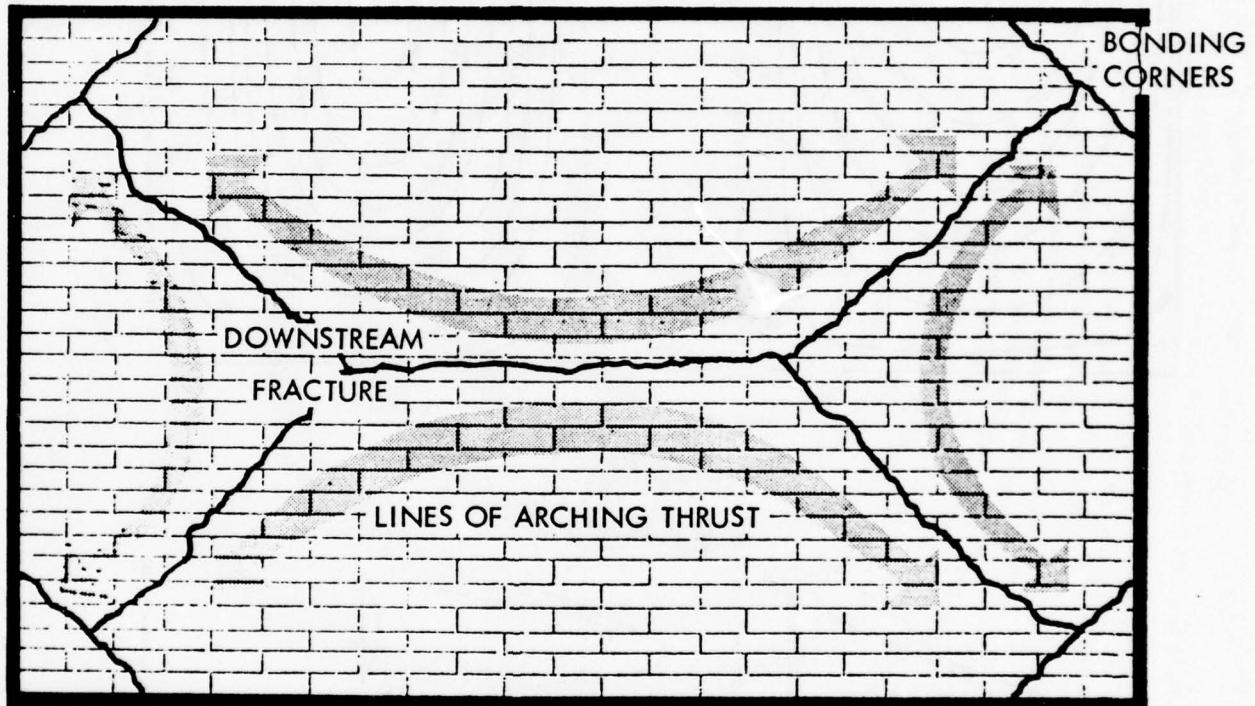
Fig. 5-6. Sketch Showing Effect of Steel Frame on Crack Pattern.

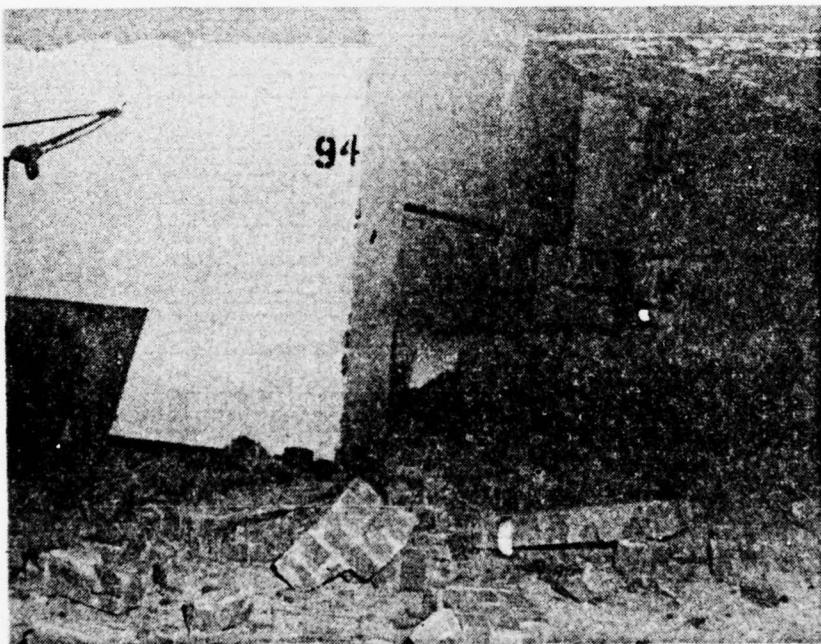
It is evident from this data that the Series No. 1 walls with failure pressure bounds of \approx 10 to 14 psi were significantly weaker than the Series No. 2 walls, with bounds of 15 to 20 psi. All data can be included within bounds of 10 to 20 psi. Sample posttest photographs of the failed walls are shown in Fig. 6-6. Fig. 6-6A is for a wall which failed at 13.9 psi near the lower bound and Fig. 6-6B is for a wall which failed at 18.8 psi near the upper bound. In general the motions of the walls were consistent with the predicted behavior of rigidly arched walls from the dynamic analysis. In Fig. 6-7, the curves are for a single wall (87) tested three times at

A. Wall No. 75. Loading Pressure \approx 13.9 psi.

B. Wall No. 94. Loading Pressure \approx 18.8 psi.

Fig. 6-6. Debris from Rigid Arching Walls that Failed Under Blast Loading.

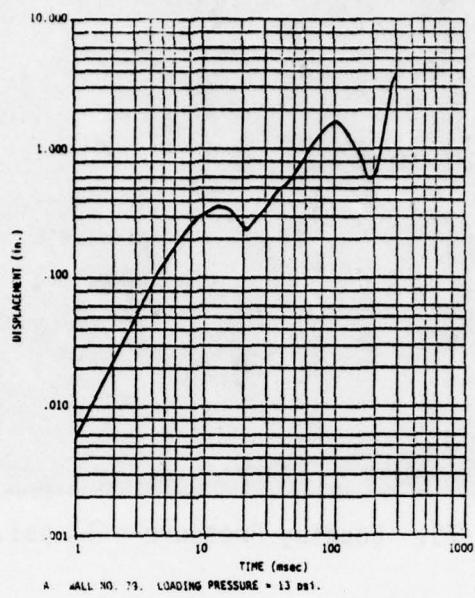
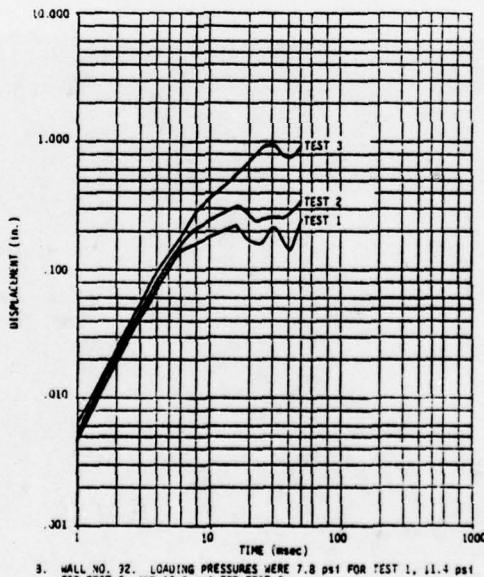
Fig. 6-12. Posttest Photographs of Rigid Arching Concrete Block Walls after Failure.

or near the centerline, and the entire wall was projected downstream. It is for this reason that the measurements of wall centerline displacement shown in Fig. 6-11 (which were made on a part of the walls that remained standing) suggest that wall recovery occurred. Note that Wall No. 77 was subjected to three tests (at blast loads of 7.4, 4.3, and 7.6 psi) and "failed" on the third. Plotted in Fig. 6-11 are the displacement measurements of the first and third tests on this wall. Wall No. 78 was tested only once at 10.2 psi and "failed" in a similar manner. Its measured displacements are shown in Fig. 6-11B. Photographs of the two failures are shown in Fig. 6-12.

A. WALL NO. 79. LOADING PRESSURE = 13 psi.

B. WALL NO. 22. LOADING PRESSURES WERE 7.8 psi FOR TEST 1, 11.4 psi FOR TEST 2, AND 12.9 psi FOR TEST 3.

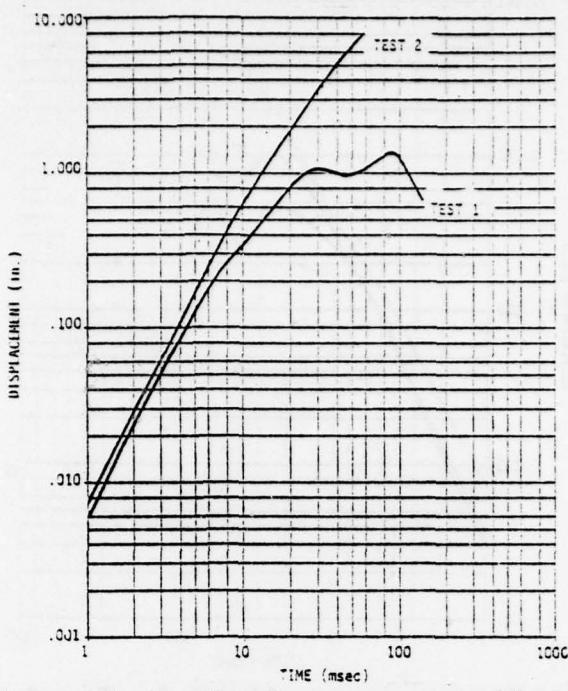
Fig. 6-15. Displacement vs Time Record and Posttest Photograph of Debris from Arching Brick Walls (No. 86 and 95) with a Doorway.

Brick Wall With a Doorway. Wall No. 86 was installed so as to undergo rigid arching. It was tested twice at about 14 and 20 psi and cracked but did not fail. Its displacement vs time history is shown in Fig. 6-15A.

The wall with a doorway (No. 95) was tested before the theory for gapped arching was developed. It was subjected to a blast load of about 21 psi and failed. Its displacement vs time history is shown in Fig. 6-15A, and a photograph of the debris created is given in Fig. 6-15B. Gapped arching theory suggests that this wall should be considerably weaker than its rigid arching counterpart. Both the displacement history and the photograph tend to bear this out.

- A. Loading Pressures were 14 psi for Test 1, 20 psi for Test 2, with Wall No. 86, and 21 psi for Wall No. 95.

- B. Posttest Photograph of Wall No. 95 (Gapped Arching) Looking Downstream.

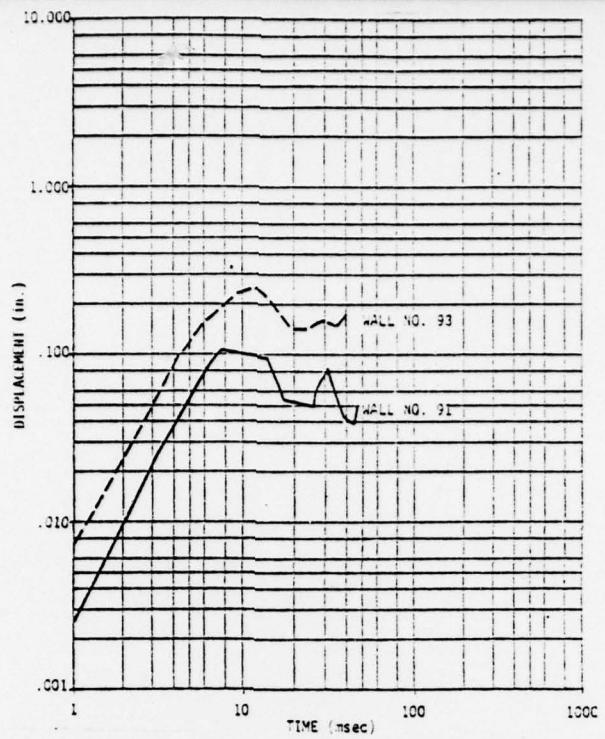
Fig. 6-16. Centerline Displacements vs Time and a Posttest Photograph of Rigid Arching Brick Walls with Windows.

Brick walls numbered 84 and 85 were first subjected to initial blast loads of about 15 psi, both cracked but did not fail. Wall No. 84 was then exposed to a 18.7 psi blast load and failed. The displacement vs time history of these tests is shown in Fig. 6-16A. After withstanding its initial loading, Wall No. 85 was then exposed to initial blast loads of 14.1 and 18.0 psi and though cracking increased, the wall remained upright. Finally it was subjected to a blast load of almost 24 psi, which caused failure. One side of the wall failed completely; the other side remained standing, though a portion of its downstream wythe of brick was broken off (see Fig. 6-16B). The walls appeared to be somewhat stronger than their solid counterparts undoubtedly because of the relief of downstream-directed loading due to the blast wave passing through the window opening.

A. Wall No. 84. Loading Pressures were 15 psi for Test 1,
18.7 psi for Test 2.

B. Posttest Photograph of Wall No. 85.

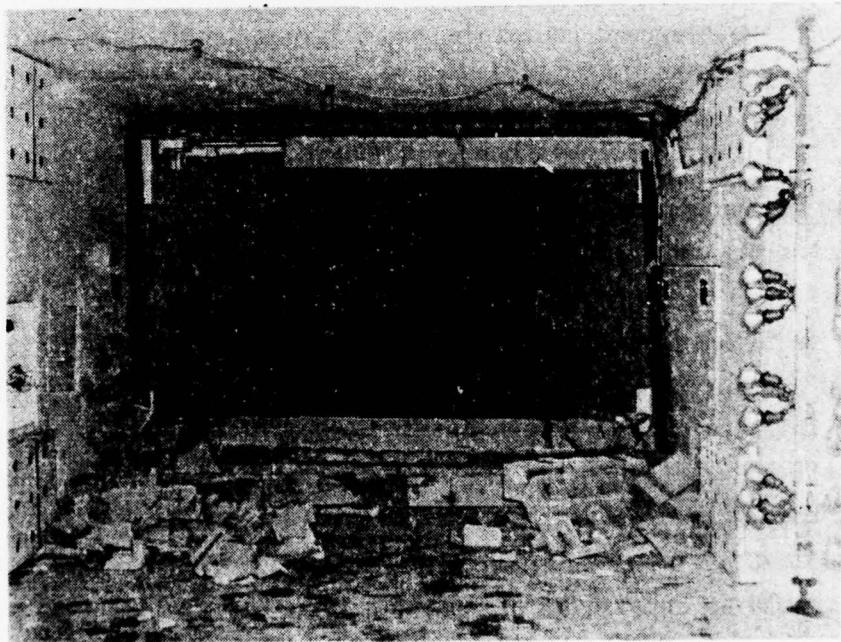
Fig. A-5. Posttest Photograph Showing Both Downstream (Foreground) and Upstream Sets of Wall Blocks, and the Remains of a Concrete Block Wall Still Attached to the Upstream Girder.
